# Situation Photo Log

Saturday, September 01, 2012

Kalamazoo River / Enbridge Spill

Prepared by:  
Dan Zahner  
START-USEPA  
Situation Unit Leader

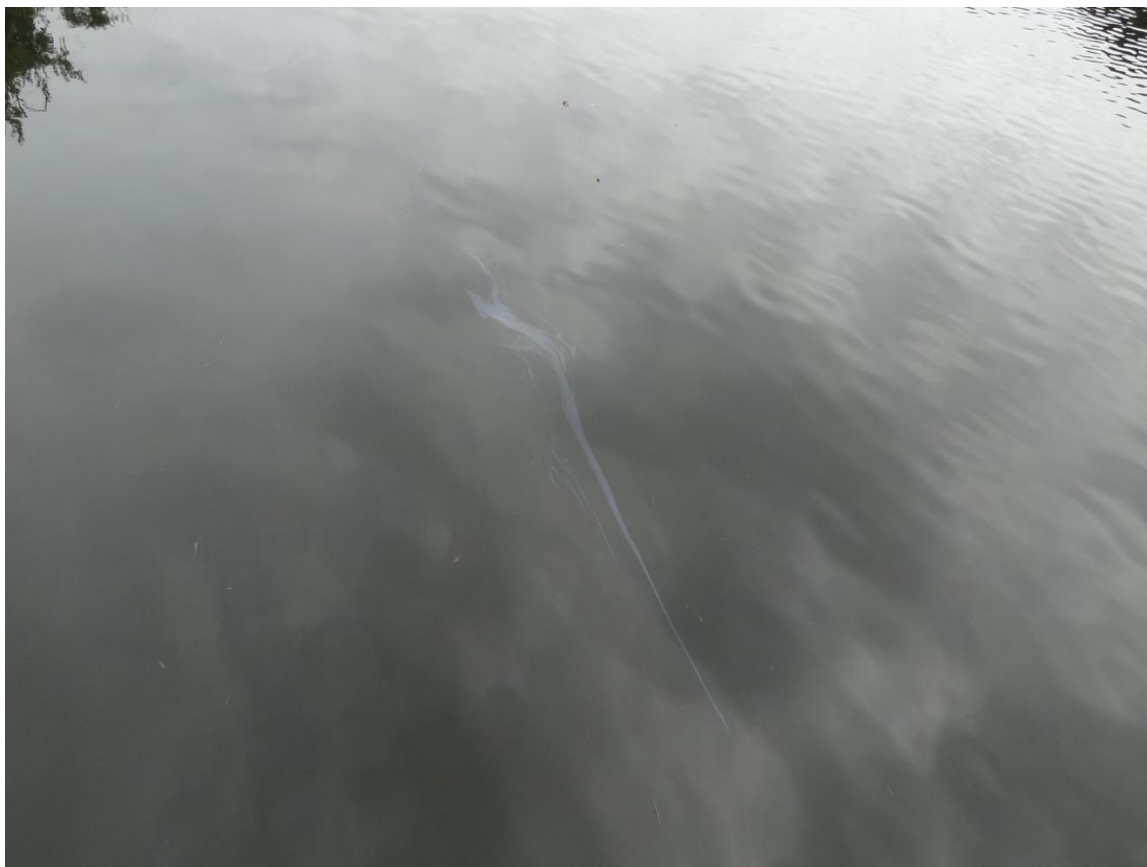
1. MP 5.10 RDB, sheen observed upstream of C 0.4 Boat Launch.

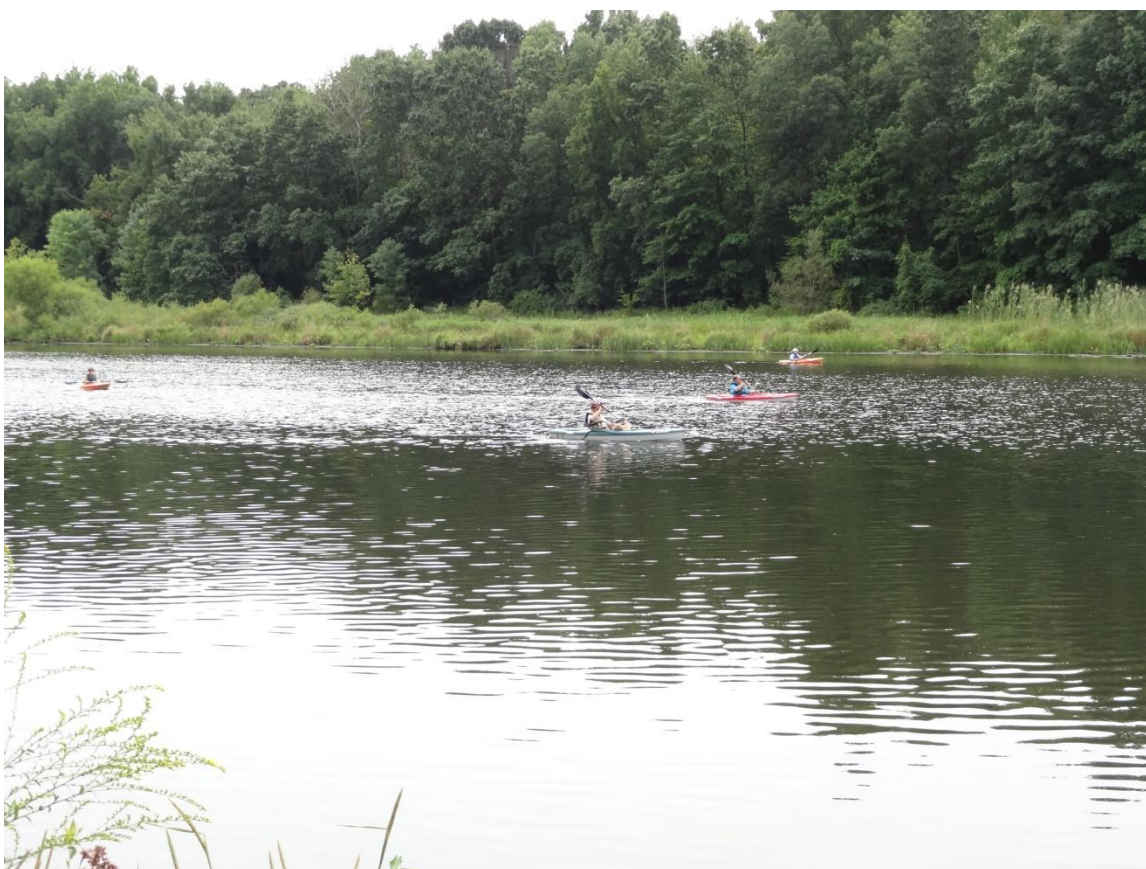
2. C 0.4 Boat Launch, public observed using the river.

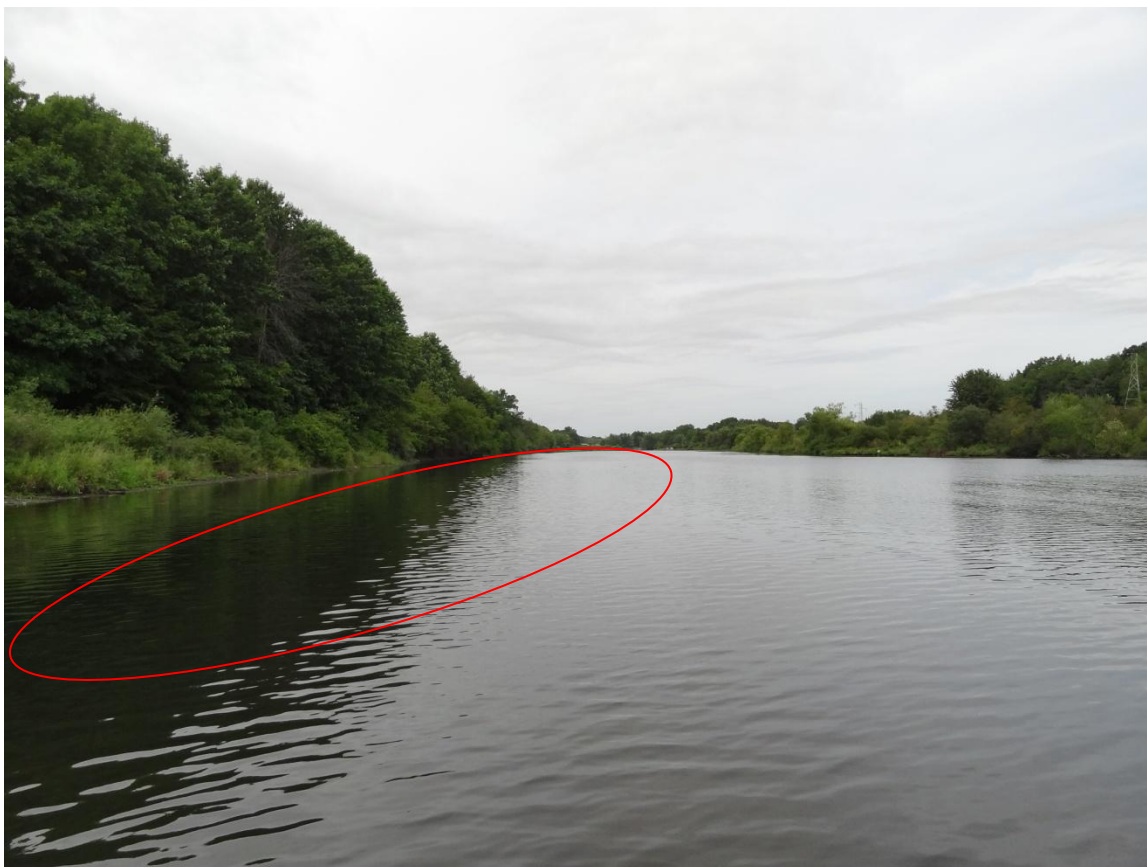
3. MP 5.15 to MP 5.63, area where sheen and tar globules were observed.

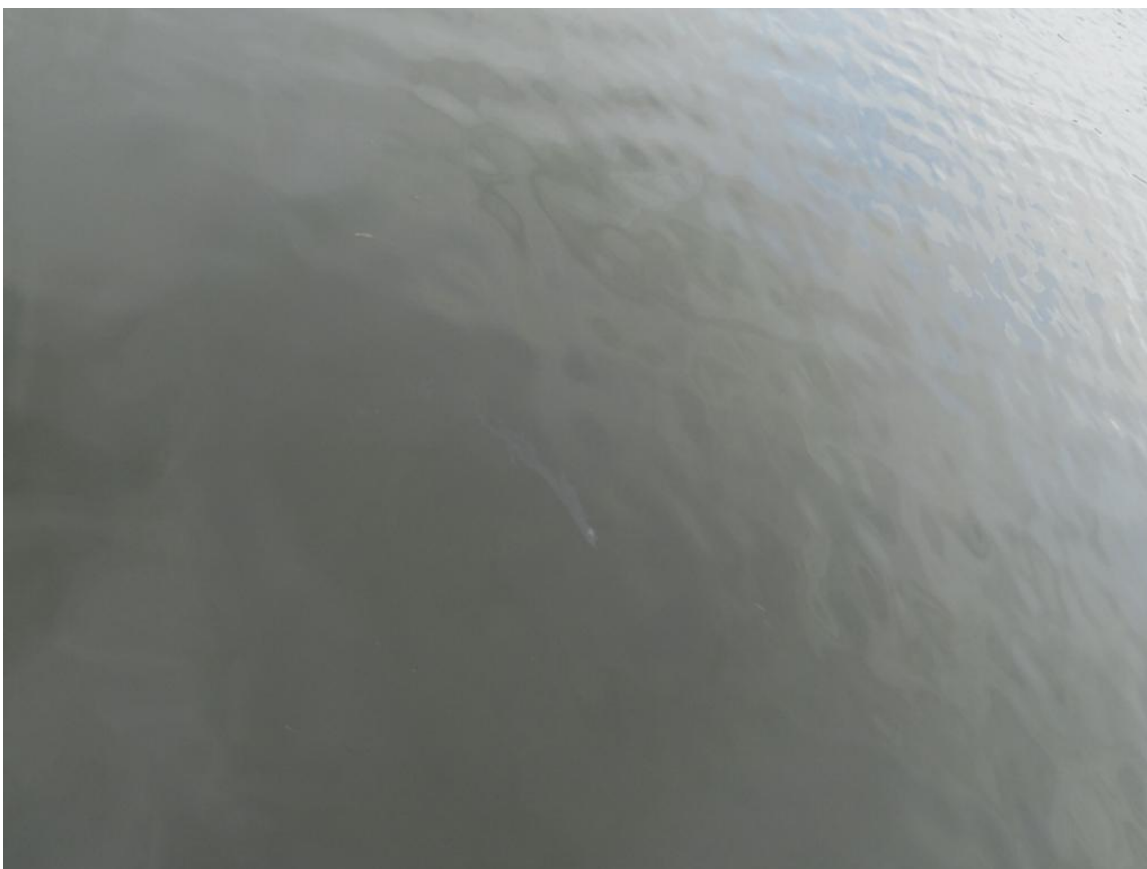
4. MP 5.25 LDB, sheen and tar globules observed.

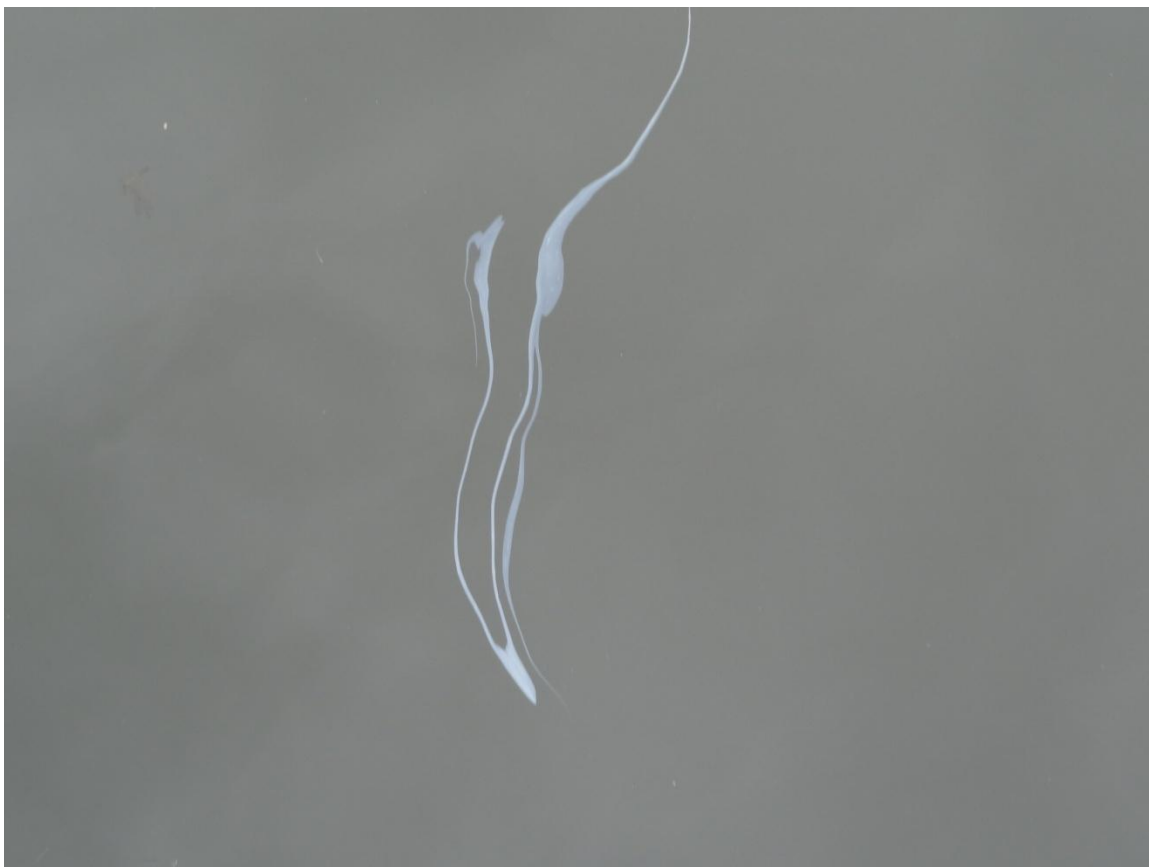
5. MP 5.50 LDB, sheen and tar globules observed.

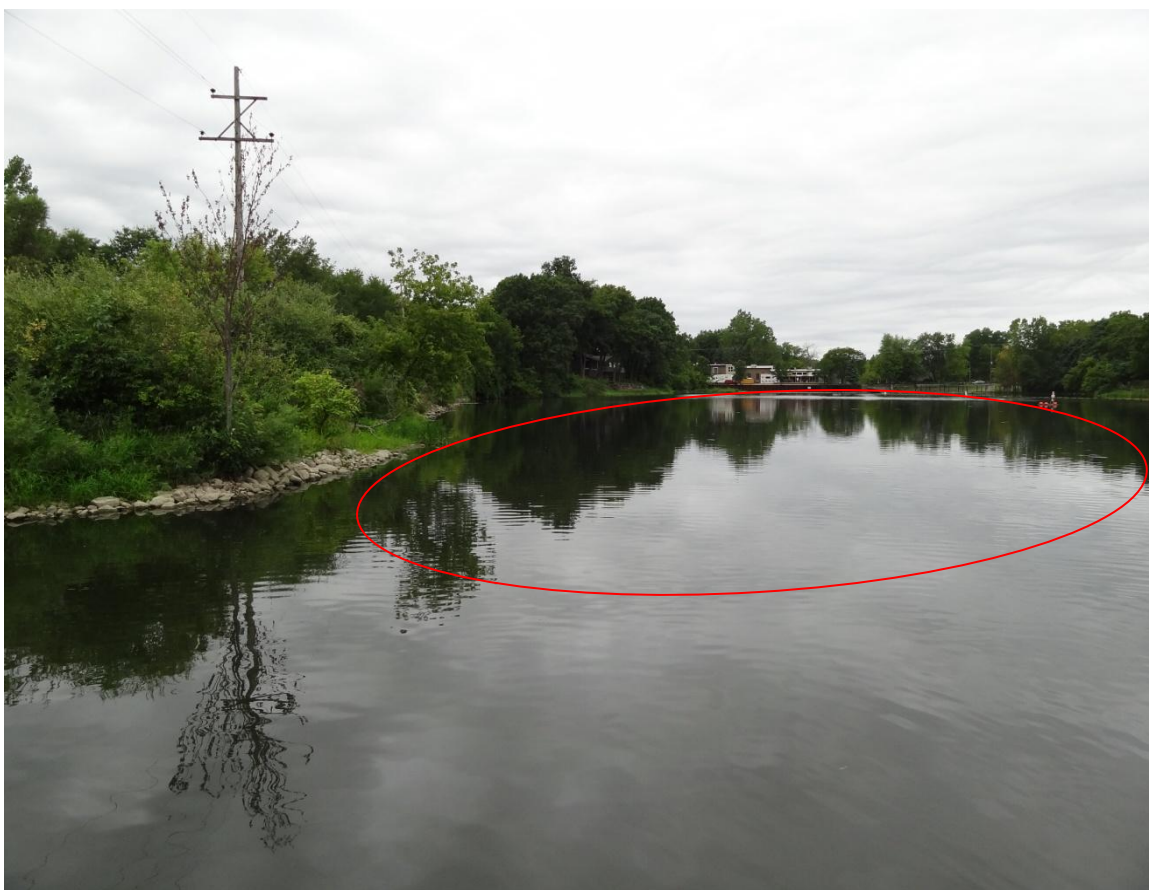
6. Ceresco Dam Impoundment, area where sheen and tar globules were observed.

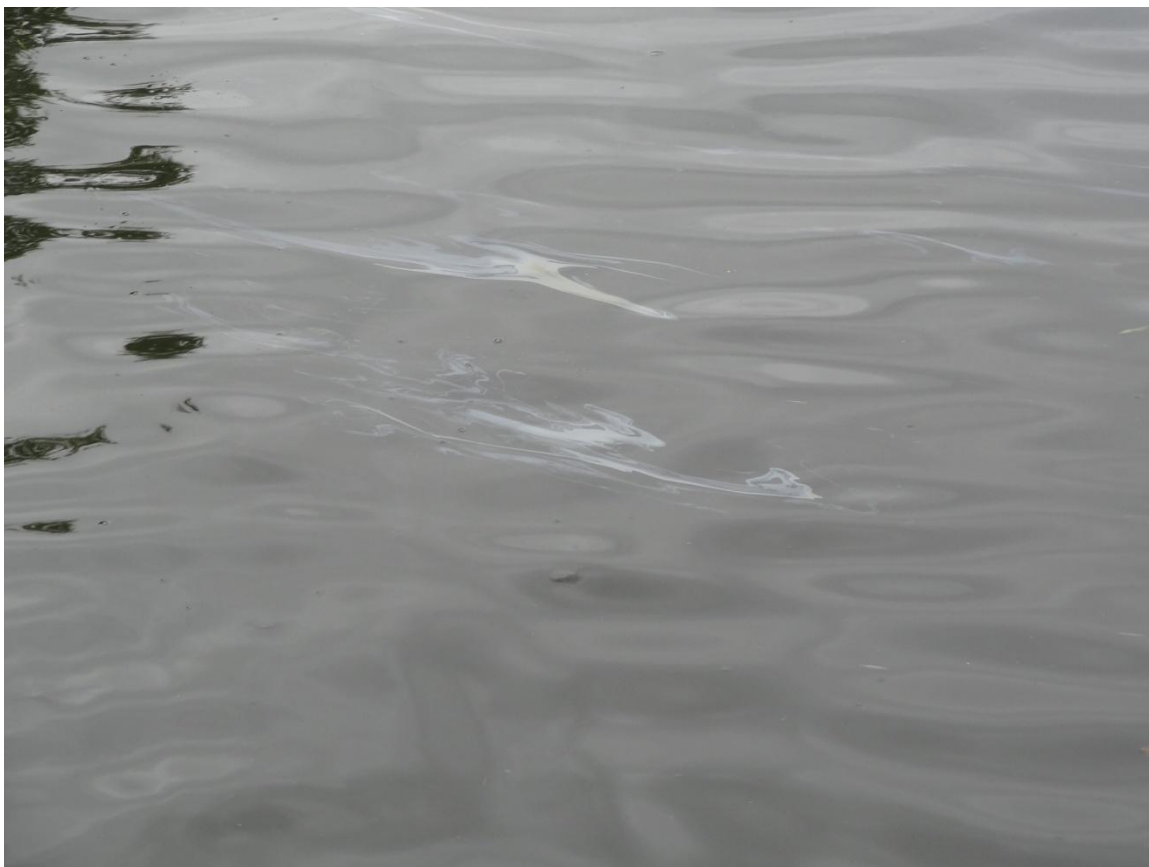
**7. Ceresco Dam Impoundment, sheen and tar globules observed within containment.**

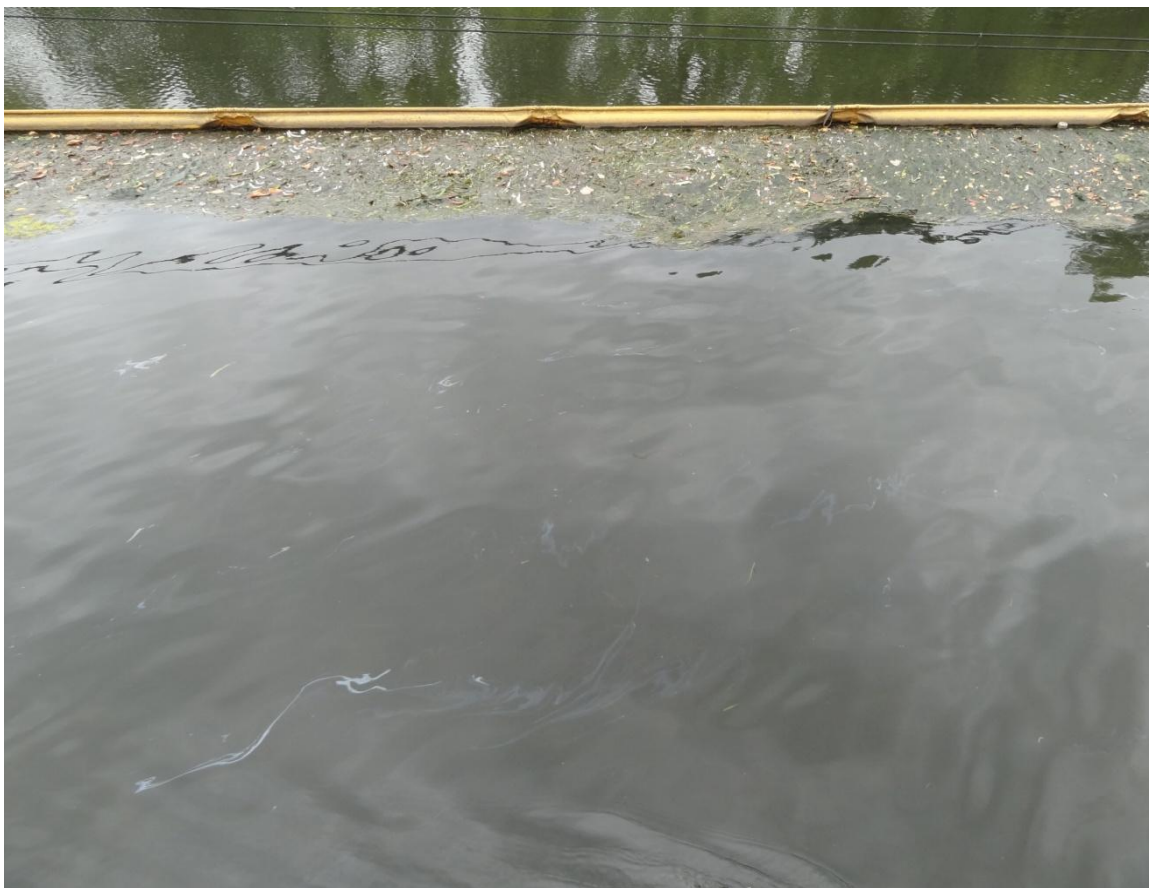
**8. Ceresco Dam Control Point, sheen and tar globules observed.**

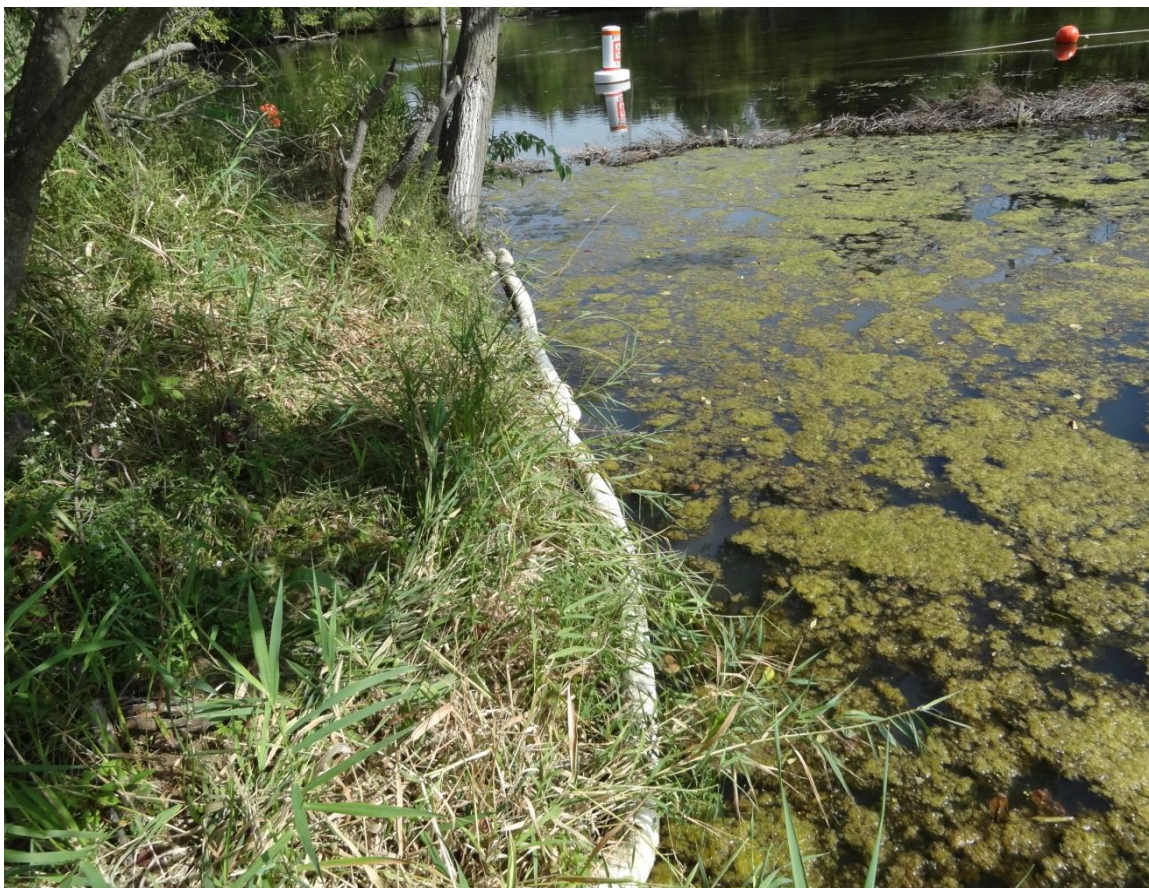
9. MP 10.75 LDB, absorbent boom remains in place around undercut bank.

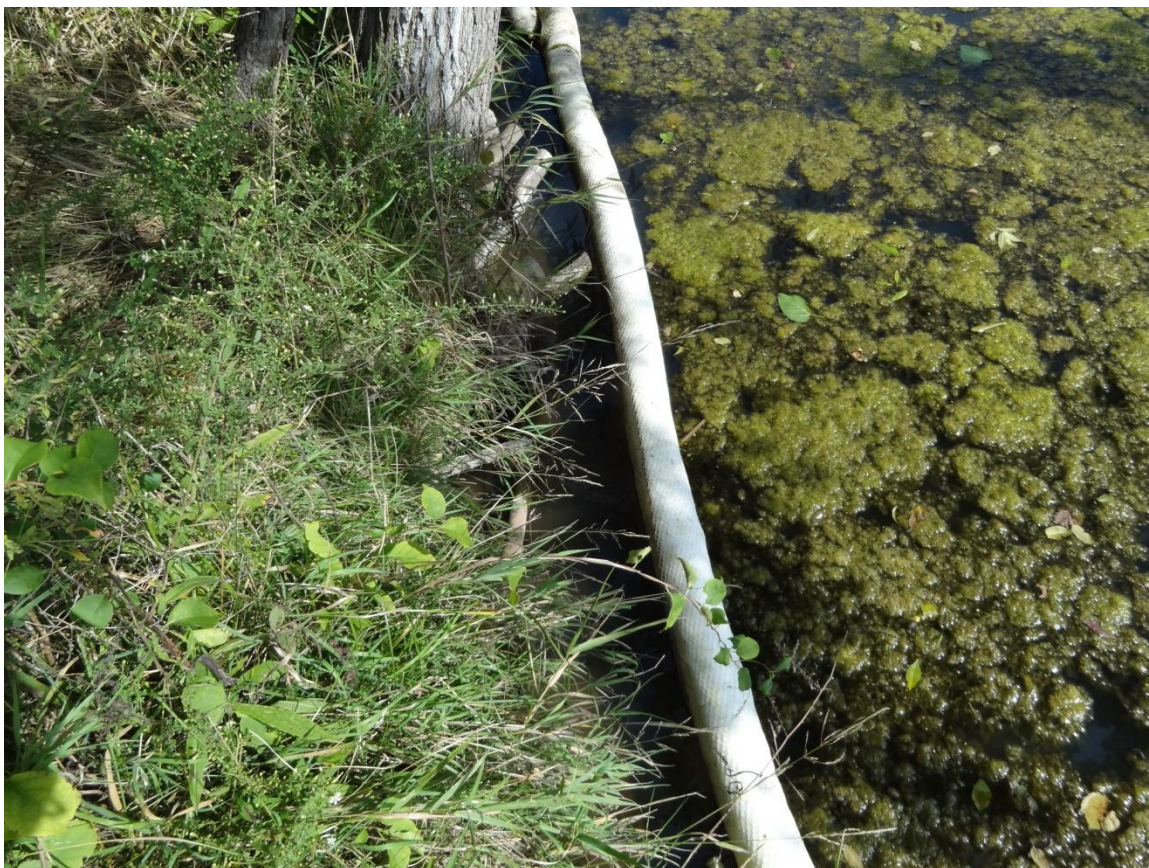
10. MP 10.75 LDB, no sheen observed within containment.

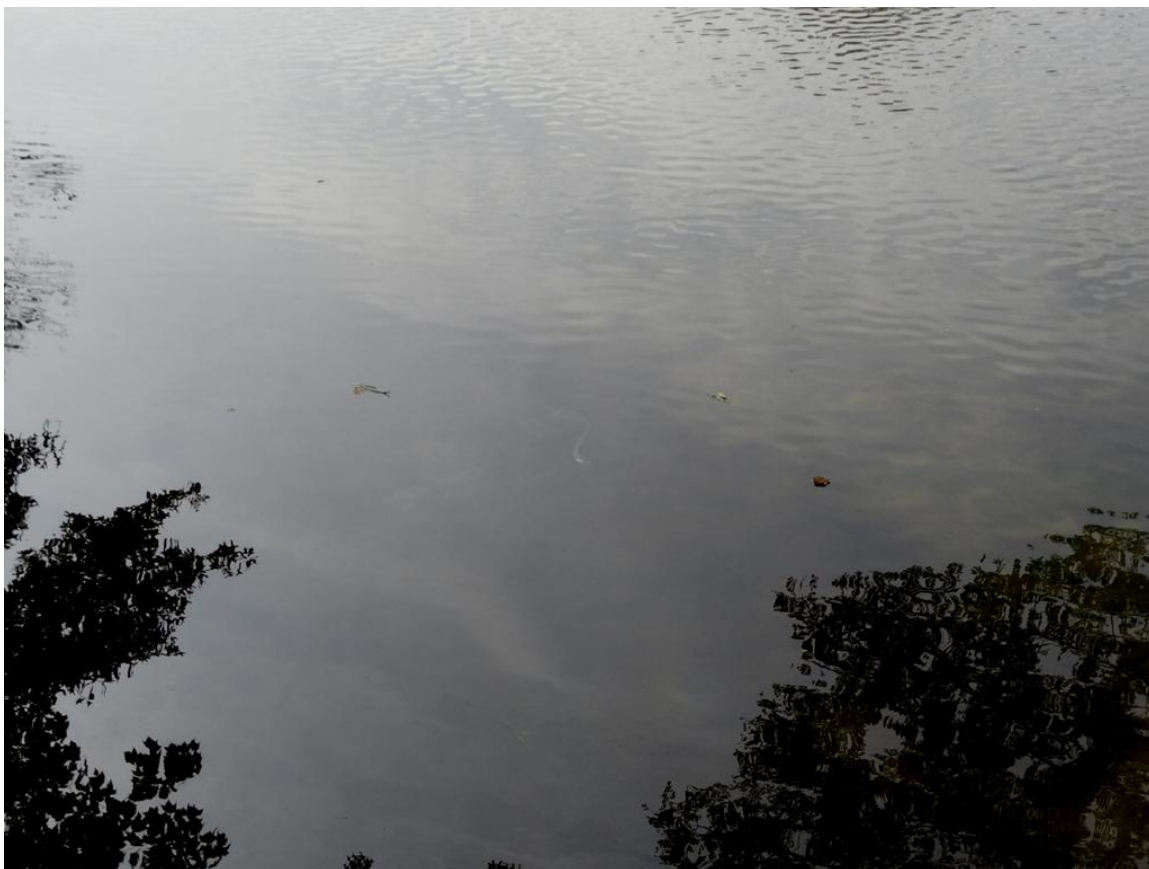
12. MP 14.85 RDB few streamers of sheen observed, no response required.

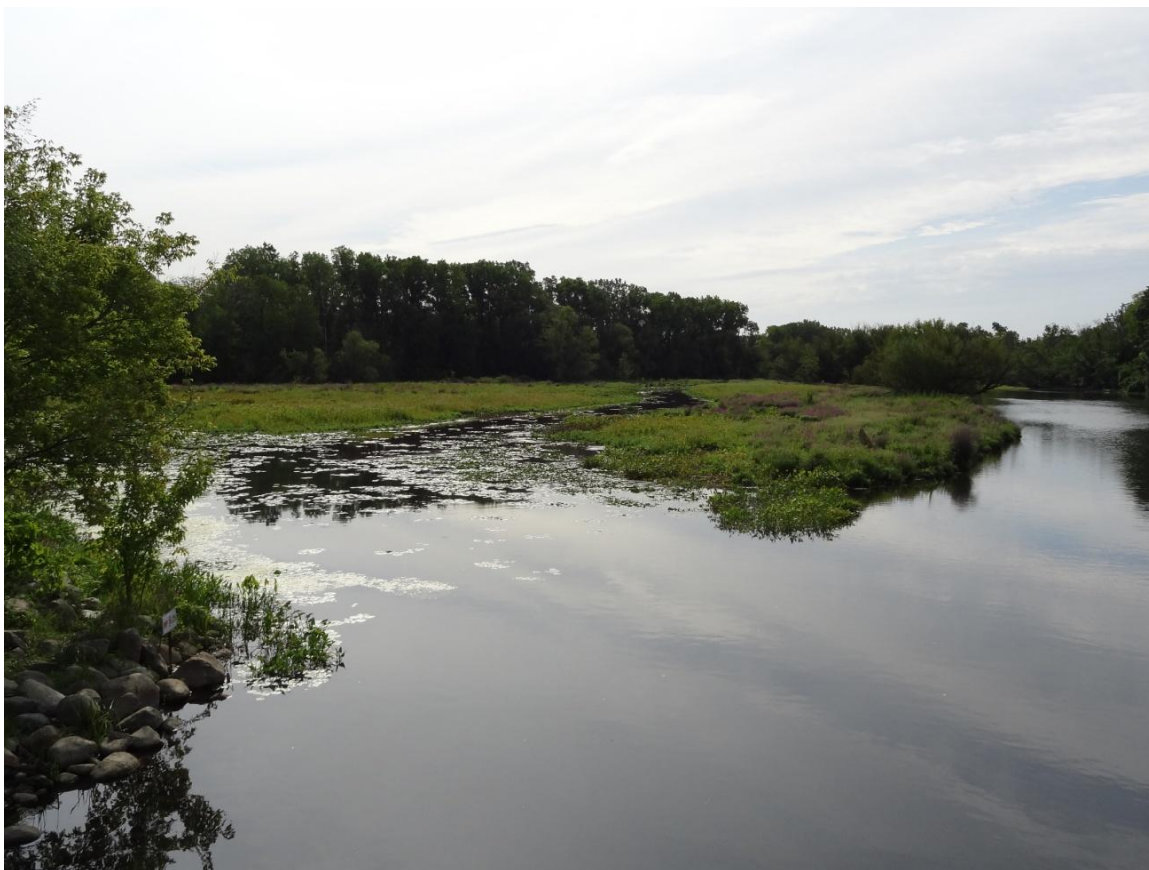
13. South Mill Pond few streamers of sheen observed, no response required.

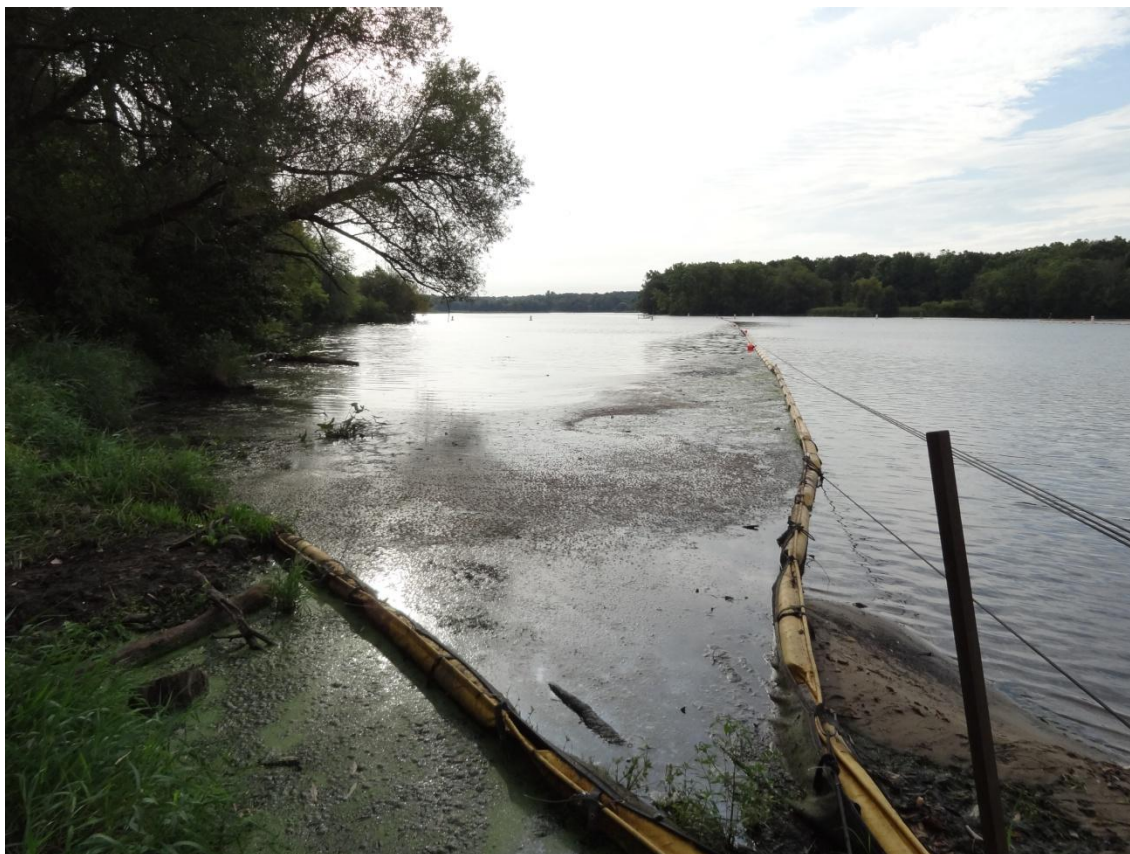
15. Morrow Lake Delta, no access due to hunter activity.

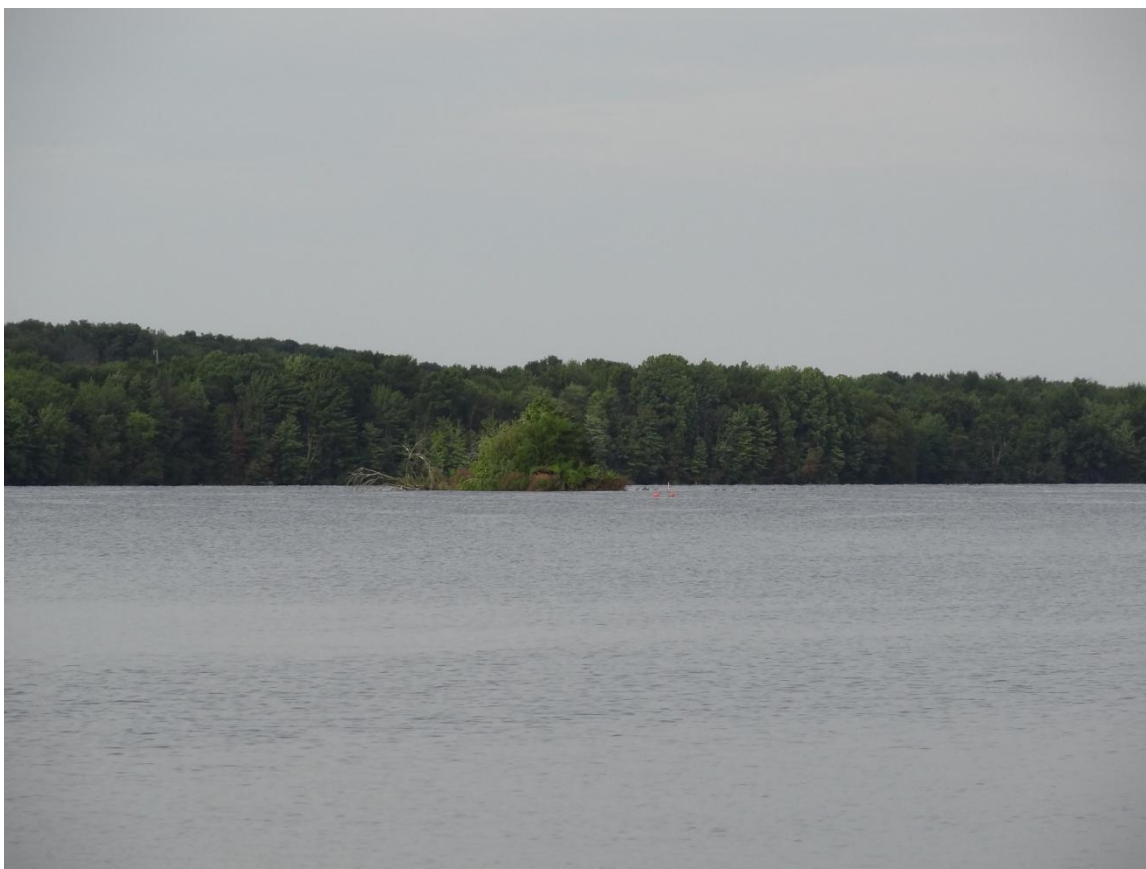
16. Morrow Lake Island at MP 38.25, goose hunters observed on Island.
